NASA Technical Memorandum 105355

Properties Data for Opening the Galileo's Partially Unfurled Main Antenna

Kazuhisa Miyoshi and Stephen V. Pepper
Lewis Research Center
Cleveland, Ohio

February 1992

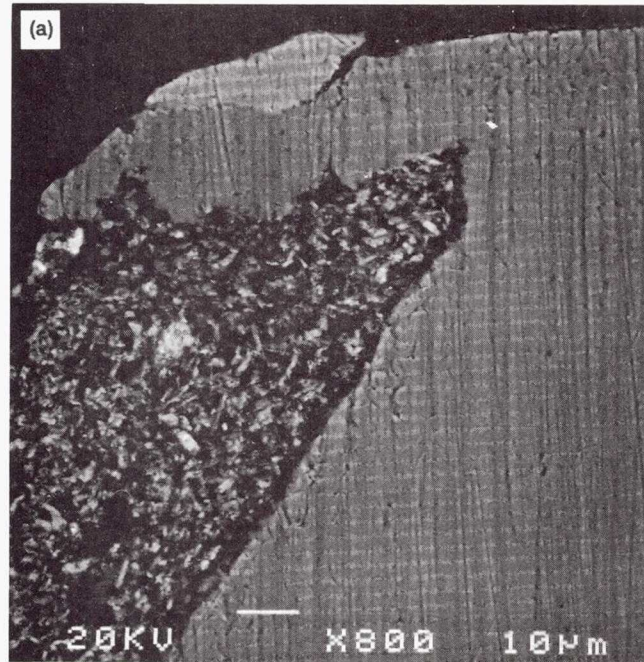
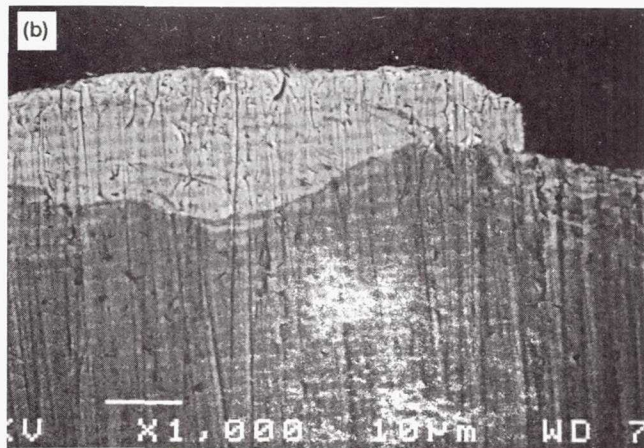
(a) Backscatter electron image SEM showing extrusion out of the wear scar.

(b) Backscatter electron image SEM showing a transferred patch of Inconel 718 on the worn surface of Ti-6Al-4V pin.

Figure 27.—A taper cross section of the worn surface of the dry-film-lubricated Ti-6Al-4V pin.

Figure 26, a taper cross section of the worn surface of the dry-film-lubricated Ti-6Al-4V pin shows clearly that the dry-film lubricant is not present on the worn surface. Further, in the overview photomicrograph, extrusion out of the wear scar and transferred patches of Inconel 718 are also well defined because of effective atomic number contrast. In figure 27 plastic deformation of the Ti-6Al-4V (extrusion out of the wear scar) and local solid-phase welding between Ti-6Al-4V and transfer patch of Inconel 718 (often referred to as scuffing) were well defined by the backscatter electron image SEM.
